## WIDENING, STRENGTHENING AND REPAIR OF A MASONRY BRIDGE IN PONTECESO (GALICIA, SPAIN)

**Abstract.** *The paper summarizes the process of inspection, characterization of materials, assessment, project of the complete solution and the technical assistance to the execution of this masonry arch bridge. Special attention is given to the description the difficulties and boundary conditions of such a task, especially the durability of stones and the micro-piling of piers and abutments as a competitive solution to ensure the robustness of foundations, and insensitivity to scour, as well as rapidity of execution, avoiding under-water works. This bridge, which is included in the Catalogue of historical bridges of Galicia, has been widened, strengthened and repaired under the criteria of modern restoration recommendations and the principle of reversibility of intervention.*

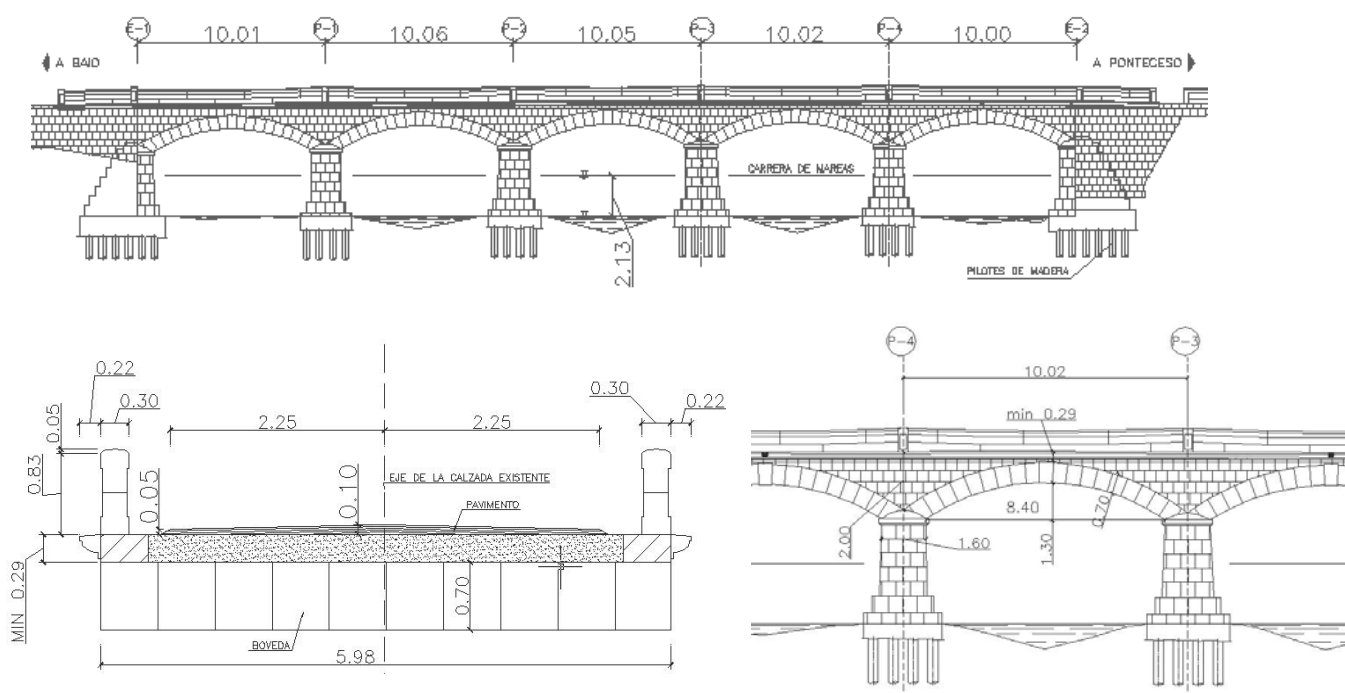
The bridge consists of five circular vaults with 8,40 m free span, 1,30 m rise, 0,70 m thickness, about 0,30 m fill thickness above crown and almost 6 m width. The four piers were founded on wooden piles of about 10 m length, driven in mud, as were the abutments. Figure 2 summarizes the main geometrical features of the bridge.

Fig. 2. Elevation, cross section at crown and details of the bridge prior to intervention.

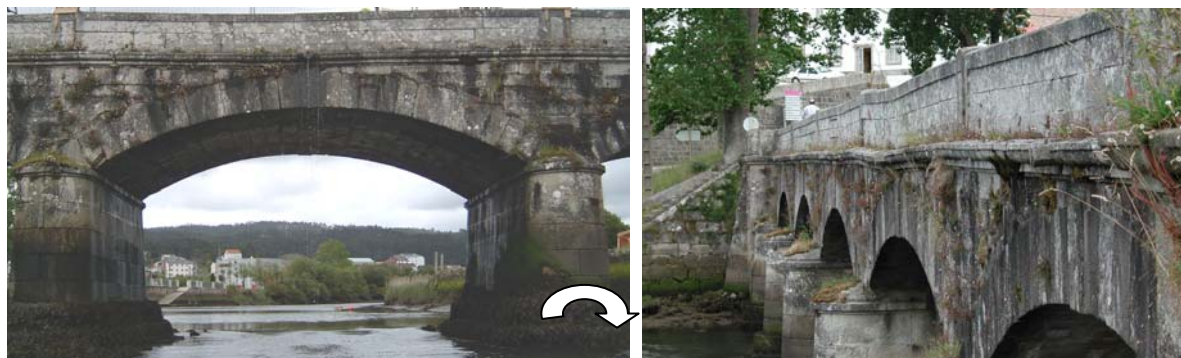
A rotation of the first pier from the left (fig. 2) was detected during the first inspection (fig. 3), inducing the opening of joints in the second barrel, incipient dropping of vaults and

evident deformation of the roadway. Some durability problems were also detected at springings, showing a lesser quality of the stone as expected; moreover, calcium carbonate precipitated on surfaces. Figures 3 and 4 show different aspects of such situations.

Fig. 3. Rotation of pier 1, opening of joints in barrel and settlement of roadway.

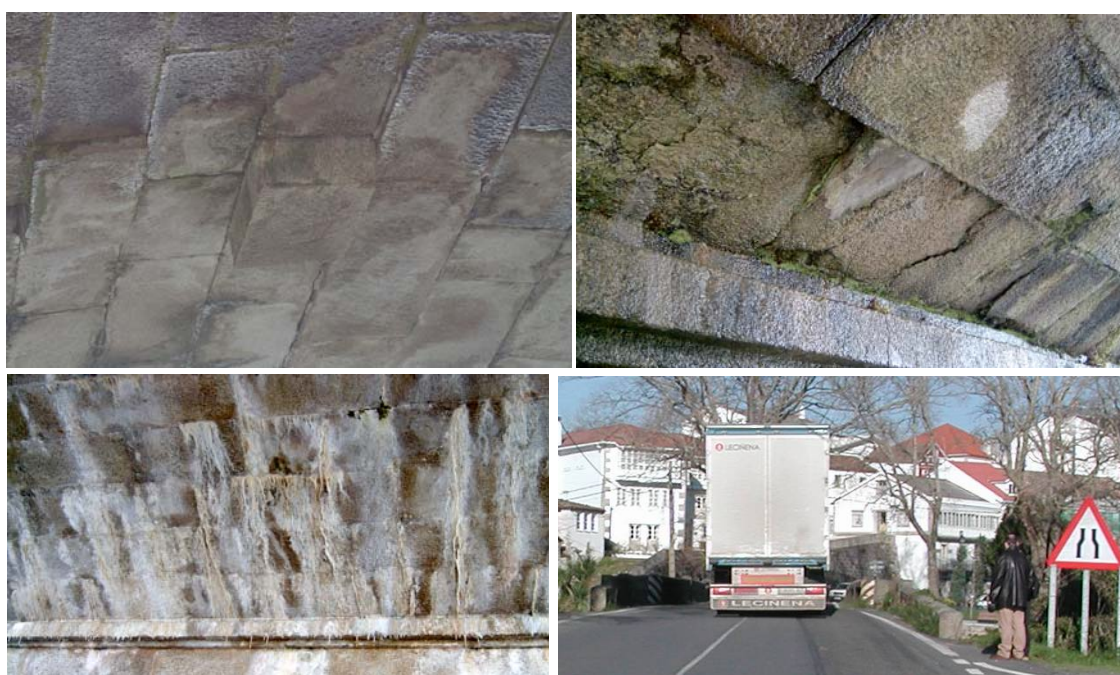
Finally, the reduced width of the platform impaired the crossing of vehicles (fig. 4) and, moreover, pedestrian ran important risks when crossing the bridge, without the opportunity of enjoying a beautiful area like this. After a first assessment, the load was limited to 15 t.

Fig. 4. Dropping voussoirs, delamination at springings of the vaults, precipitation of calcium carbonate and functionality default of the bridge, too narrow to allow the crossing of vehicles and pedestrians.

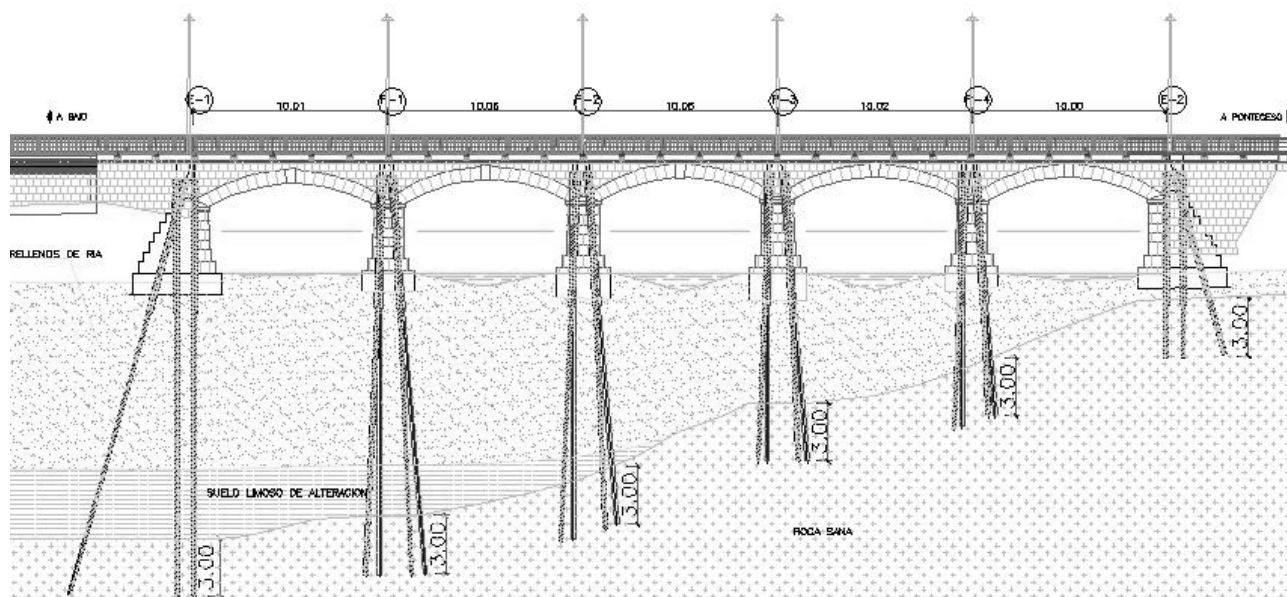
Fig. 6. General elevation of the projected and executed solution. The micro-piled abutments and piers guarantee stability of movements and sufficient bearing capacity for the loads required by the current standard

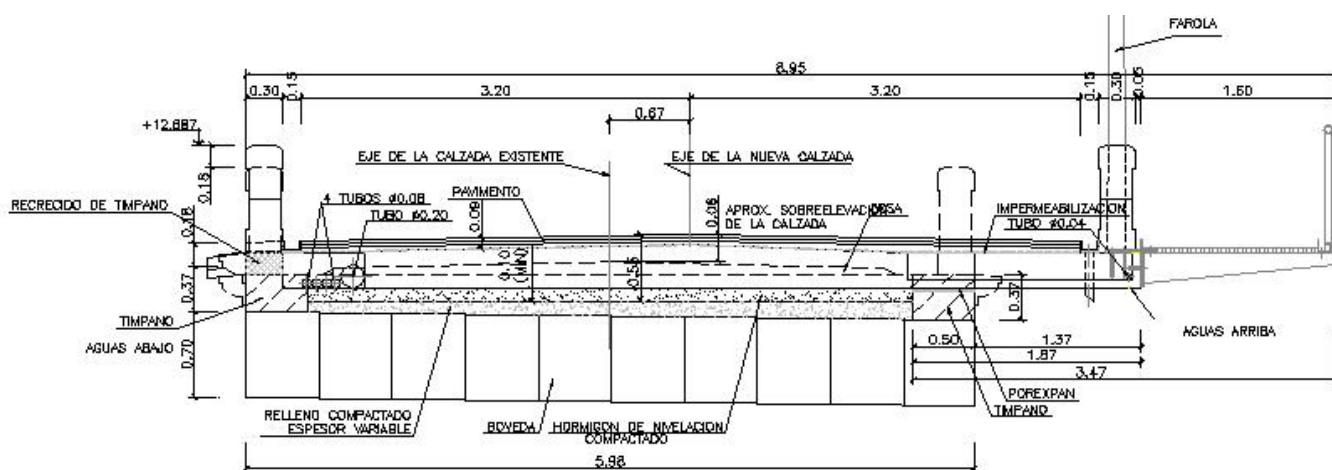
Fig. 7. Cross section of the widened platform. The deformed shape of the barrel reflects its real state detected after the geometrical survey. Therefore, it was necessary to adapt slabs and geometry specifically for each barrel, pier and abutment.

Fig. 7 shows the cross section of the final solution, compared to its original dimensions. As can be seen, the road platform was constructed by means of a concrete slab, consisting of partially precast elements, and the pedestrians' sidewalk was made of a galvanised steel grid, quite transparent in order to avoid excessive shade on the upstream elevation and, in addition, to avoid excessive eccentricity on the piers and abutments.

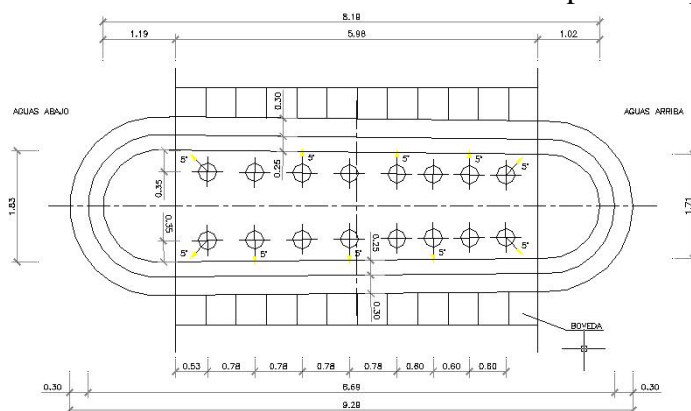
Fig. 8. Layout of micro-piles within the piers, as a combination of vertical and inclined piles to carry out both vertical and horizontal actions.

The micro-piling of piers and abutments were designed in such a way that the piers themselves constituted a pile-cap. This decision was taken after considering the possibility of creating a plynth or basement at the bottom of each pier and arranging the micro-piles around it. This possibility was disregarded due to the difficulty of working beneath the vaults, the tidal movements of the water level and the unaesthetical appearance of such a solution. On the contrary, the pier itself would transmit the vertical forces from the barrels and platform to the micro-piles by bond or friction along the distance between the springings of vaults and the bottom part of the pier. However, one of the disadvantages of this solution was the increased length of micro-piles and the highly required accuracy of execution, due to the high density of holes, that had to be located on the outer parts of the piers and not inside the in-fill material, of much poorer quality. Figs. 8 and 9 respectively show the adopted solution of micro-piling and the strut-and-tie models used to design them. While it was possible to find a path of struts without ties on the abutments, the piers required horizontal nailing to equilibrate the tensile forces generated around the mechanism of bond transfer between piles and piers.

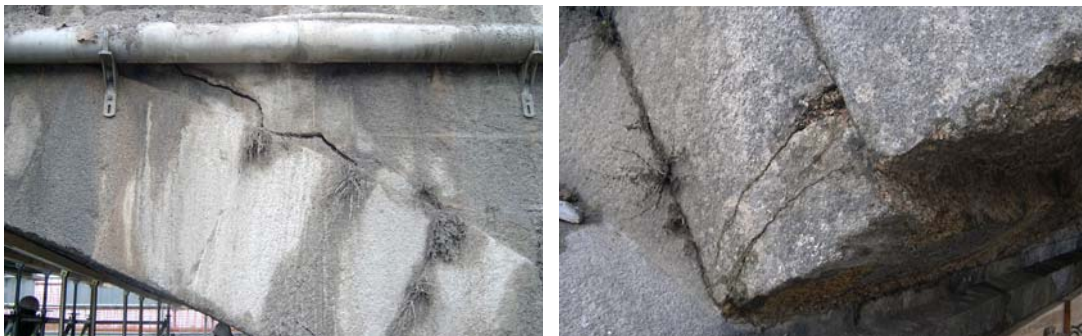
The order in which the foreseen activities should succeed revealed to be essential, especially in this case of high concentration of piles and bad soil quality. Indeed, an attempt to shorten the time of execution provoked an alarming situation since the vertical displacement of the crown of the second barrel (second on the left in fig. 10), induced new defaults, ring-spandrel separation and crushing of springing voussoirs, as shown in fig. 11.

Fig. 11. Ring-spandrel separation and crushing of the springing voussoirs induced by wrong doing while drilling pier 1.

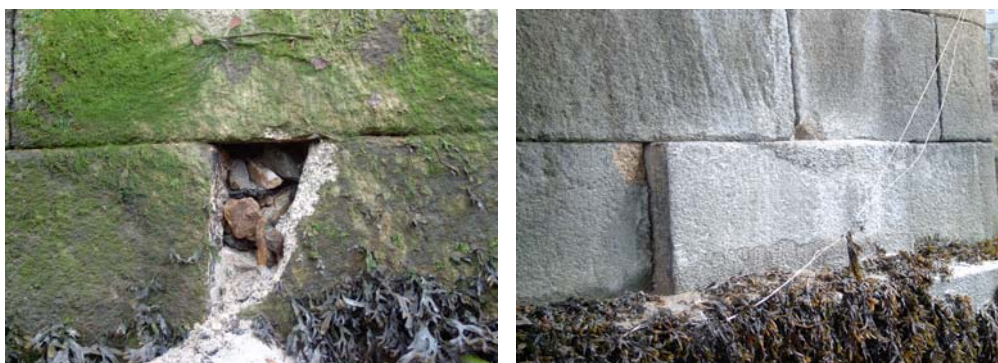
Moreover, the drilling operation, with rather reduced stone cover and relatively high horizontal pressure during drilling, induced some other problems, as shown in fig. 12.

Fig.12. Partial breaking of the ashlar's cover of a drillhole (left) and transverse movement induced by transverse pressure (right).

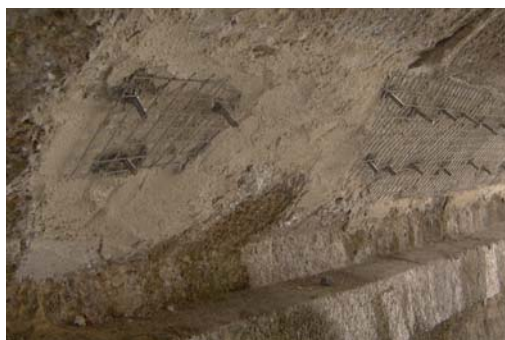
Fig.13. Repair of lost material at springing of voutes.

The material lost by deterioration of the gneis stone and the spalling induced by the thrust line at the springings of barrels was replaced by tixotropic mortar, especially designed for the purpose (3 parts of white portland cement, 3 parts of white siliceous sand 3 mm, 15% biotite), and confined with stainless steel rods  $\varnothing$  10 mm every 0,30 m, as shown in fig. 13.
